Model 1208 - 6 Meter Transverter - PC Board Error

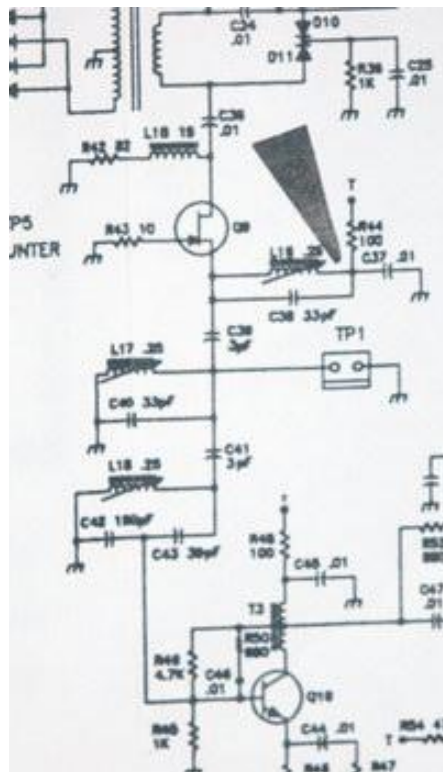
On my board the 3rd hole on L16 connected the upper ground plane to a trace on the underside of the board from C37, C38, R44 and L16 effectively taking all these components to ground. A quick review of the schematic shows this is an error.

(The arrow in the figure below shows the portion of the junction grounded by the board fault.)

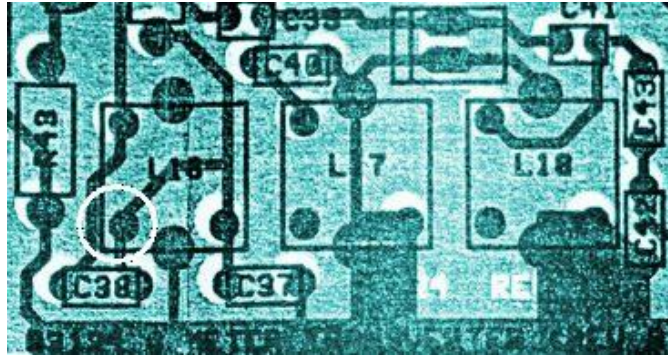
Examination of the X-Ray view shows the problem (see pad inside white circle at lower left of L16). The L17 and L18 pads connect the top ground plane to bottom ground plane BUT L16 connects the top ground plane to a trace on the under side. (Green is component side ground plane, black is underside trace, underside ground plane NOT shown.)
