# Ten-Tec Jupiter (Model 538)

## Low-pass Filter Relay & Reverse Polarity Repair

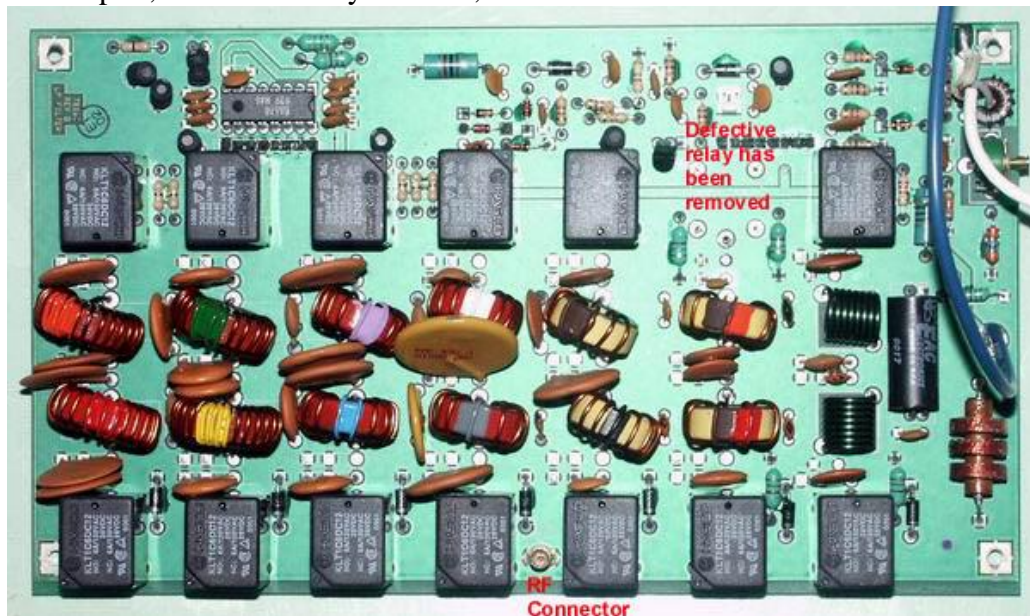
The Jupiter rig belonging to Gary VE7GGJ would not transmit on 15/17 metres. All other bands transmitted and received flawlessly.

Low-pass filter board with 15 of 16 relays installed (the defective 17/15 metre band relay has been removed)

**Carefully** unsolder and remove one of the suspect relay pairs and measure the coil resistance. If the coil is open this relay must be replaced.

Measure the coil resistance of the relay remaining on the low-pass board for the band under test. A working relay should have a coil resistance of approximately 400 ohms. A relay with an open coil **MUST** be removed and replaced.

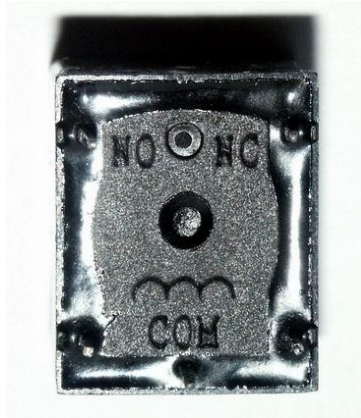
**Relay – Coil and common connection are at the bottom of the figure**

Each band combination has a pair of relays and the relay coils are wired in parallel. Measure the resistance across either of the band relay coils. The resistance should be approximately 200 ohms.

If the resistance is approximately 400 ohms this indicates that one of the relay coils is open! (In the unlikely event that BOTH relay coils are open the resistance would approach infinity.)

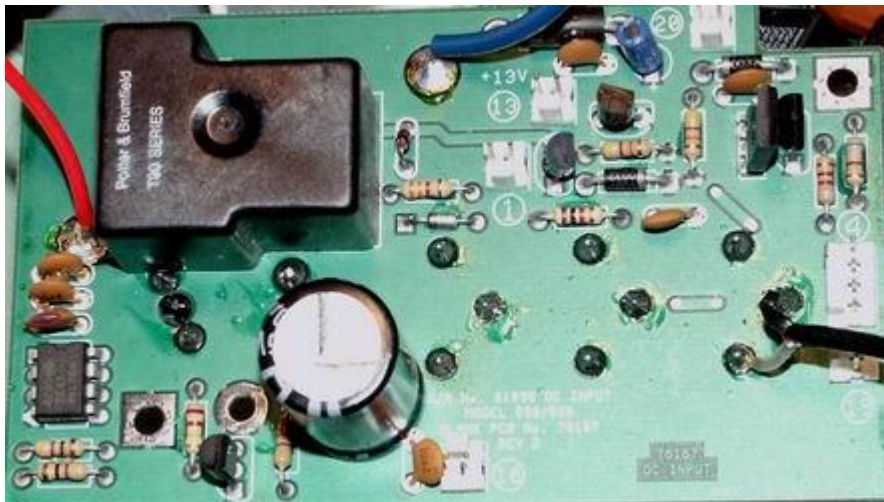
An unintended repair was needed when, after a 3<sup>rd</sup> relay failed, a change of ALL switching relays was completed. It was getting late and the power supply leads to the Ten-Tec Jupiter were inadvertently reversed. The result was smoke and a completely dead Jupiter.

After some research the problem was tracked down to the DC Input board (78187). The solution was, fortunately, fairly easy and inexpensive – whew. Transistors Q1 and Q2 were replaced (they are next to connectors 1 and 13) with 2N2222 transistors and the Jupiter was back in business. (**Note:** The RG-174 coax at the lower right of the DC input board has been added to allow the use of an RX-320 as a secondary receiver using N4PY software and may not be present.)
