3-Element SteppIR Rebuild

VE7TK – 2025

Rick Williams – August 2025

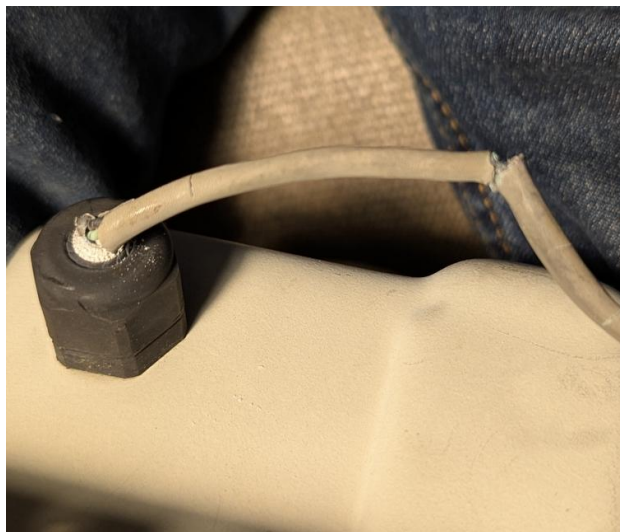
Once I was over the change in the view I started to look over the antenna. Obviously the elements needed a light sanding and repaint (I used **Brightside Interlux Polyurethane Topside**). I was quite surprised to see how deteriorated the wiring on the boom had become. The 4-conductor shielded wires from the junction box to the reflector and director element housing units (EHU) had suffered badly. The exterior jacket was gone in several places and many of those locations had lost the underlying foil shield as well. The biggest problem was, as expected, at the reflector. One of the wires in the cable was broken, disabling the Reflector stepper motor.

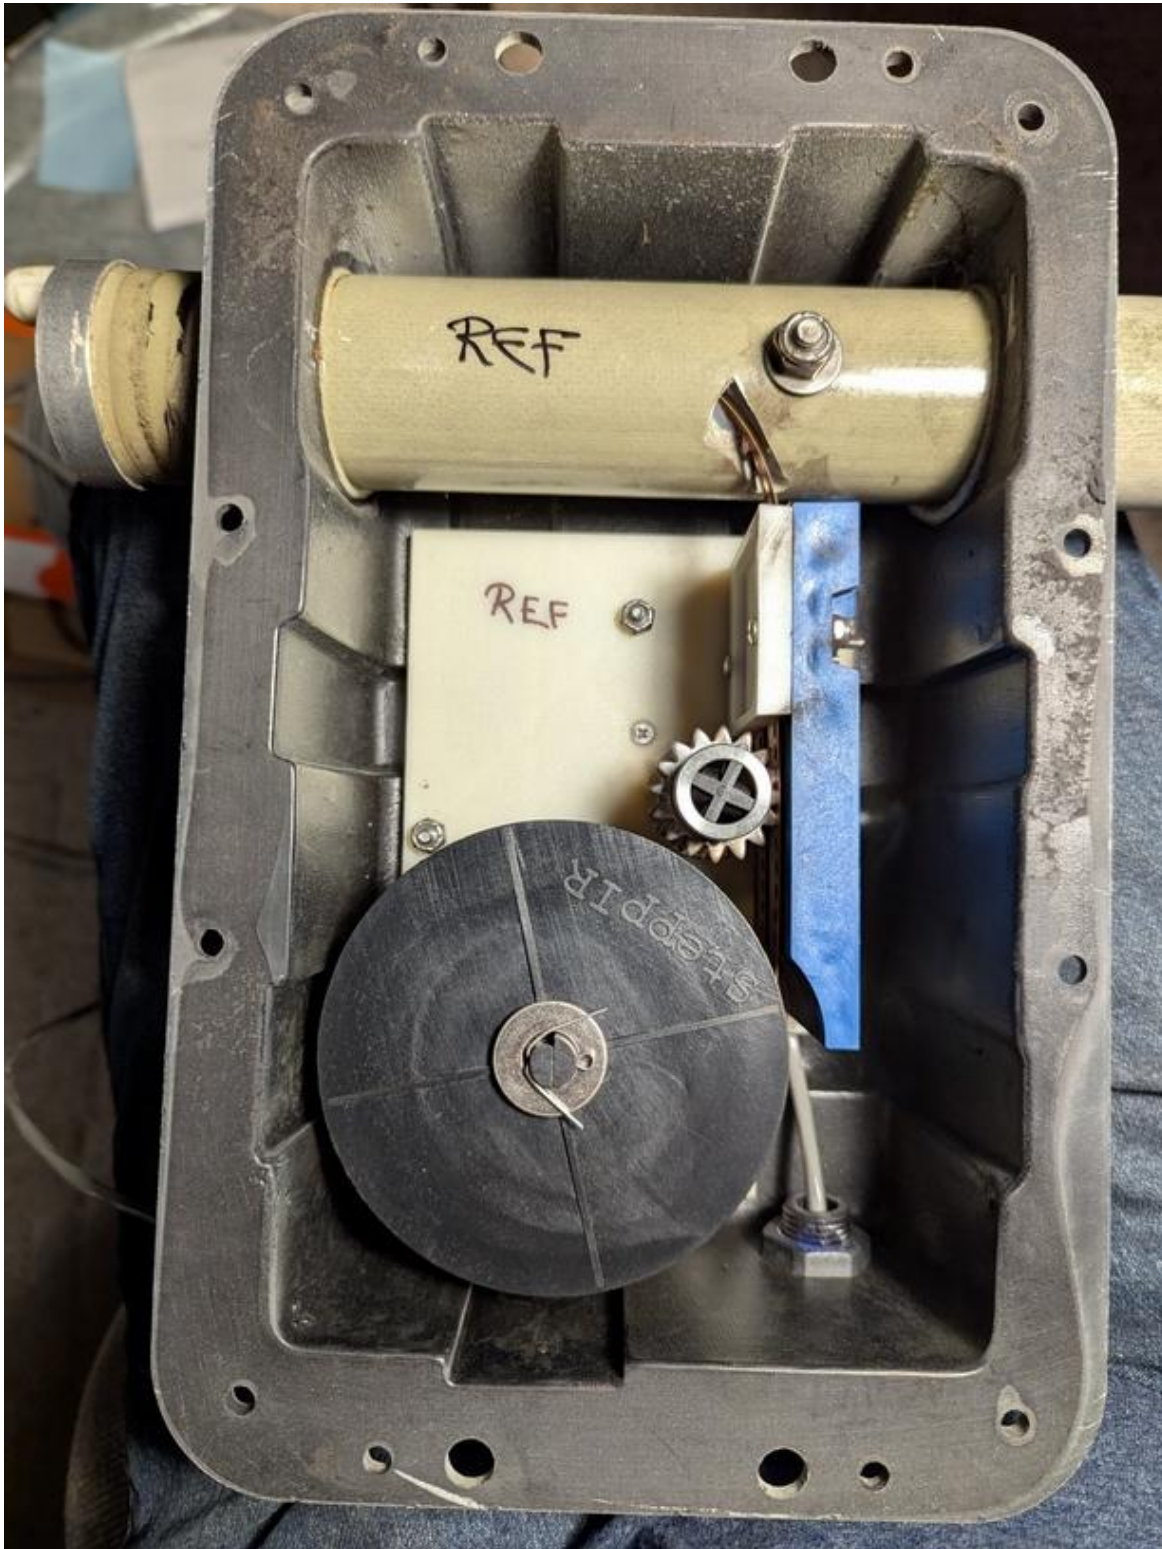
Removing the fibreglass tubes brought some better news as ALL copper tapes had been retracted into the EHU housings. When I opened the reflector housing the inside was pristine!

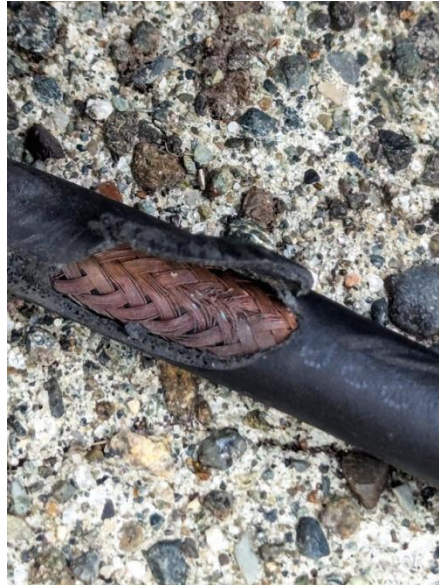
It was, however, obvious that ALL 3 of the EHUs needed rewiring. While looking over the cabling I noticed that the RG-213 coax from the antenna feedpoint to the LMR-400 was badly burned/abraded. Surprisingly there was no evidence of water intrusion. The length of RG-213 too was replaced.

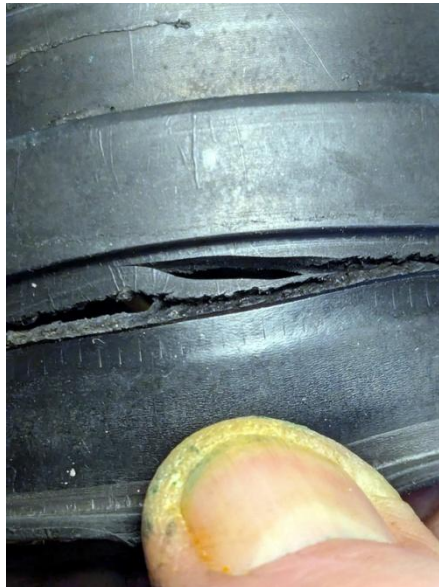
While removing the fibreglass tubes from the EHUs I encountered an additional problem. The 6 flexible couplings that secure the 6 element tubes to the EHUs had begun to split. These couplings had been covered with PVC tape to protect them from UV but they still had deteriorated badly.

Luckily the appropriate Fernco fittings (Part #P1-056-150/125) were available at the local Home Hardware (not to be confused with Home Depot)!

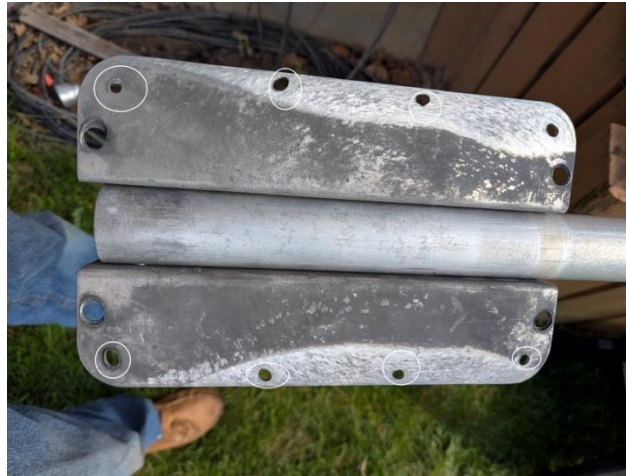
In checking over the attachment of the reflector EHU to the boom mounting plate I found another problem. The EHUs are attached to the boom plate with 8 – 10x32 stainless steel screws. On the reflector mount only 7 screws made it through 19+ years up the tower and another was loose. Examination of the aluminum mounting plate revealed that several of the mount holes were elongated and showed significant wear.

In an effort to reduce this type of movement as well as eliminate flex in the housing I fabricated a base reinforcement of 3/16th inch aluminum. To distribute the load across the mounting screws and the fibreglass EHU cover a top rail of 1/16th x 1 inch aluminum angle was also added.

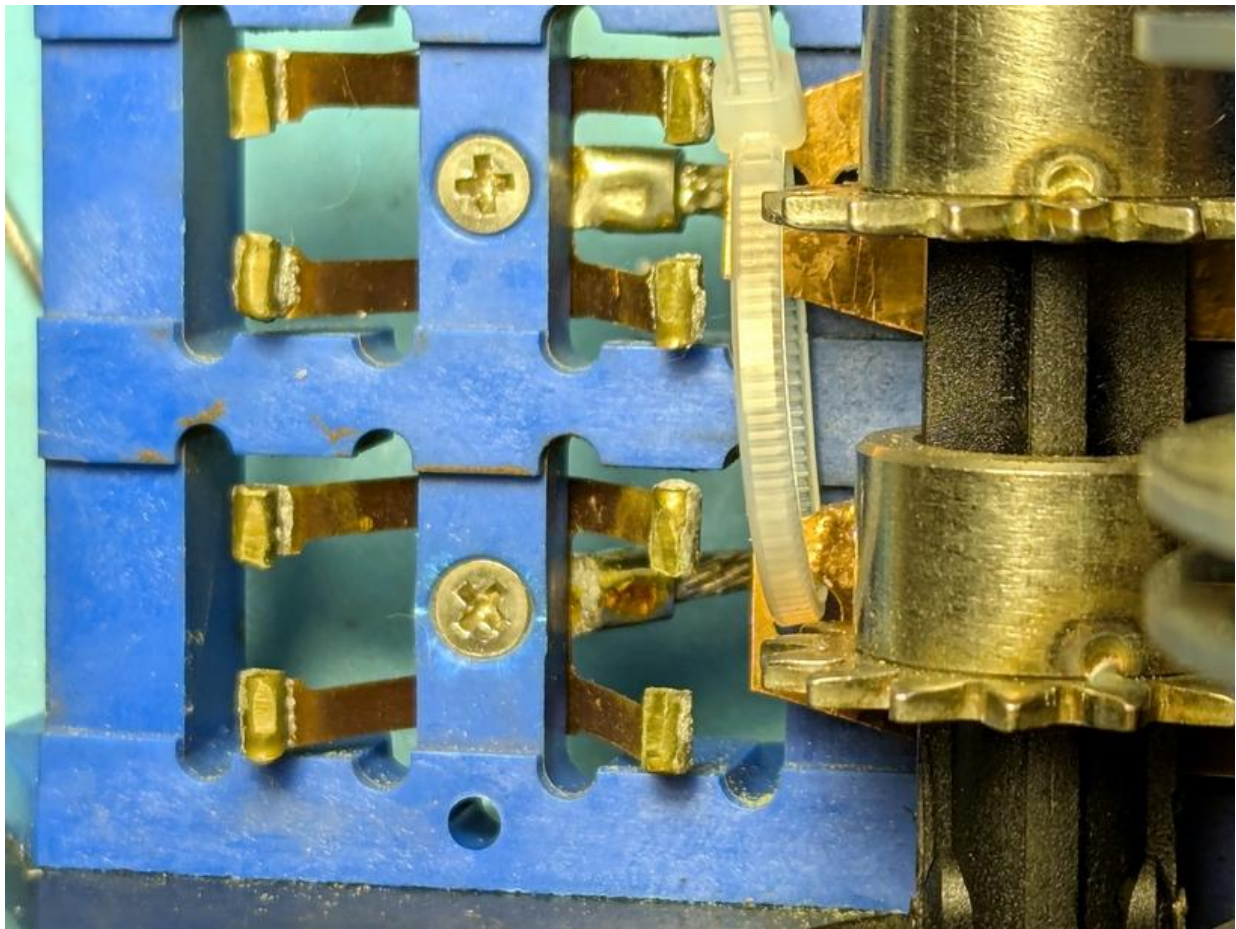
Examination of the driven element revealed the problem. The brushes that carry the RF to the copper/beryllium tapes were worn and had a significant ridge built up. It was possible that after rewiring the EHU the brushes were not making a good contact with the tape surface.

New brushes were needed. However, by this time SteppIR EHU parts were no longer available! So I decided to salvage the existing parts. The brushes were gently ground down with a sharpening stone and polished with 2000 Grit Wet/Dry paper. The tapes were then fully extended and wiped down with 99% isopropyl alcohol. With the tapes rewound, the brushes were given a final alcohol cleaning before sealing up the driven element EHU.
