TEN-TEC

Hercules II - Model 420

Vacuum Relay Modification

Prepared by Rick Williams, VE7TK

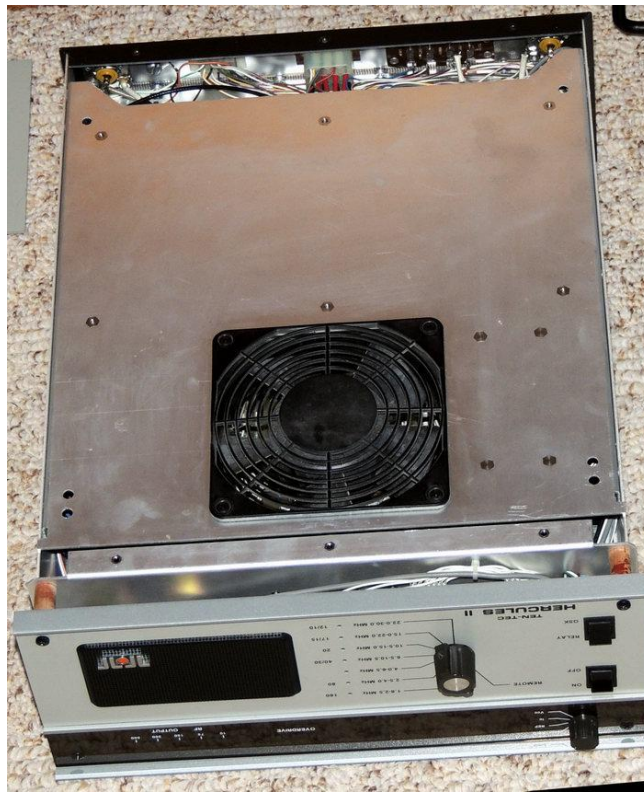
Getting to the relay requires removal of the top and bottom covers of the Hercules. There are 6 screws in the top, 6 in the bottom and 6 on the sides. With the covers removed, place the amplifier upside down and remove the 4 screws holding the plate with the fan.

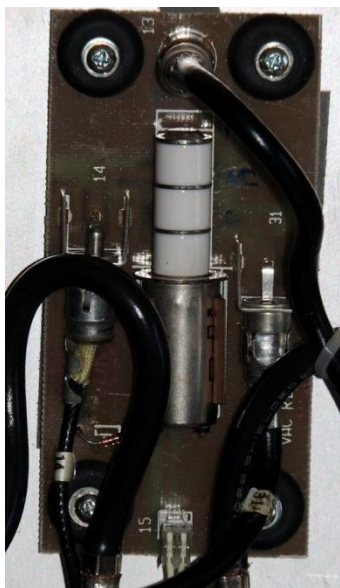
With the cover-plate and fan tilted out of the way the vacuum relay board is now visible at the right rear of the amplifier. The K41C relay is in the centre of the board in a metal bracket.

Note the position of the 3 coax connectors and power connector at plug 15 and unplug all. Remove the 4 screws holding the circuit board in place and remove the board.

The bottom of the board was covered in foam acting as a damping agent to reduce relay noise. In my case the foam had all but disintegrated. Unsolder and remove the relay from the board. Carefully drill out the stock mounting bracket.

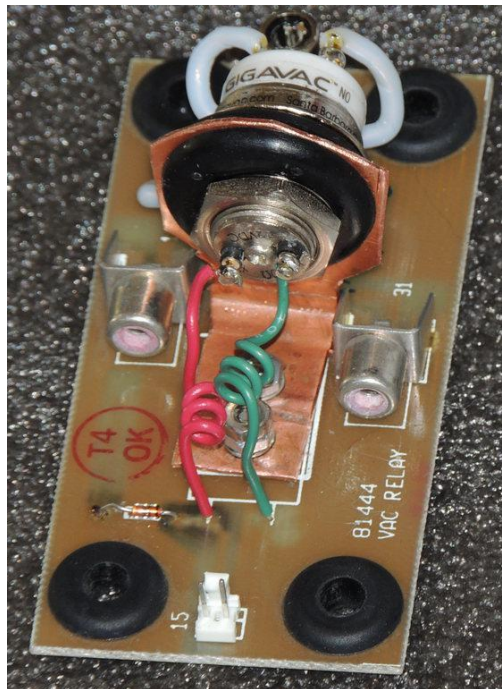
Installing the GH-1 relay requires the fabrication of a new mounting bracket. I built my bracket out of some copper material. The bracket is a simple 90 degree bend with a $7/8^{\text{th}}$ inch hole for the relay in the vertical portion and a pair of holes to accommodate 4-40 mounting screws in the narrower horizontal portion. The bracket was constructed to allow easy access to all the RCA connectors while still clearing these connectors. The 4-40 screws used the original rivet holes that held the K41C bracket. (The original holes needed to be enlarged slightly for the 4-40 screws.)

A large grommet was inserted into the new bracket's $7/8^{\text{th}}$ inch hole to provide isolation for the relay. The threads of the relay were lightly coated with RTV silicone sealant and the 4-40 screws were coated with a thread locking compound.

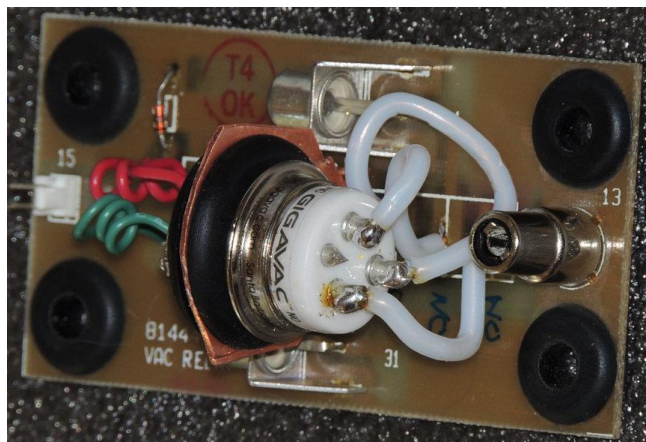
Power connections to the relay were made with #22 hookup wire. The RF connections were made with short lengths of Teflon coated wire from some RG-142 coax.
