Improving Final RF Transistor Heat Dissipation In the Ameritron ALS-1300 Linear Amplifier

Prepared by Rick Williams, VE7TK

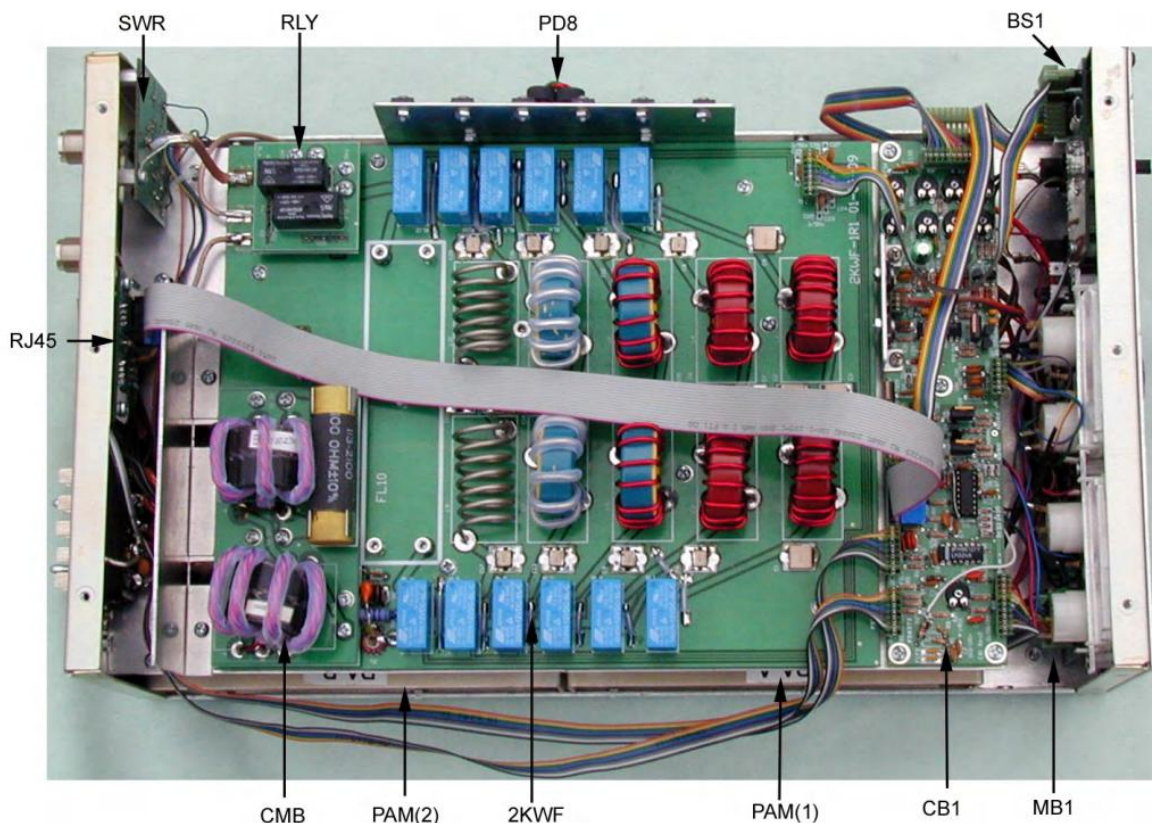
Source: FCC

When the ALS-1300 cover is removed you can see the layered structure of the unit. The top layer is dominated by the **2KWF6** filter board. Plugging into the filter board is the transmit/receive relay (**RLY**) board and combiner (**CMB**) board.

On the rear panel are the **SWR** and **RJ45** boards along with the RF input and the power connectors. In front to the filter board is the control board (**CB1**). On the front panel are the bandswitch (**BS1**) and metering (**MB1**) boards.

Below this layer the power splitter (**PD8**) board attaches to the shield separating the filter board from the power amplifiers. Finally below this shield are housed the power amplifier (**PA-A** and **PA-B**) boards (labelled **PAM(1)** and **PAM(2)** above).

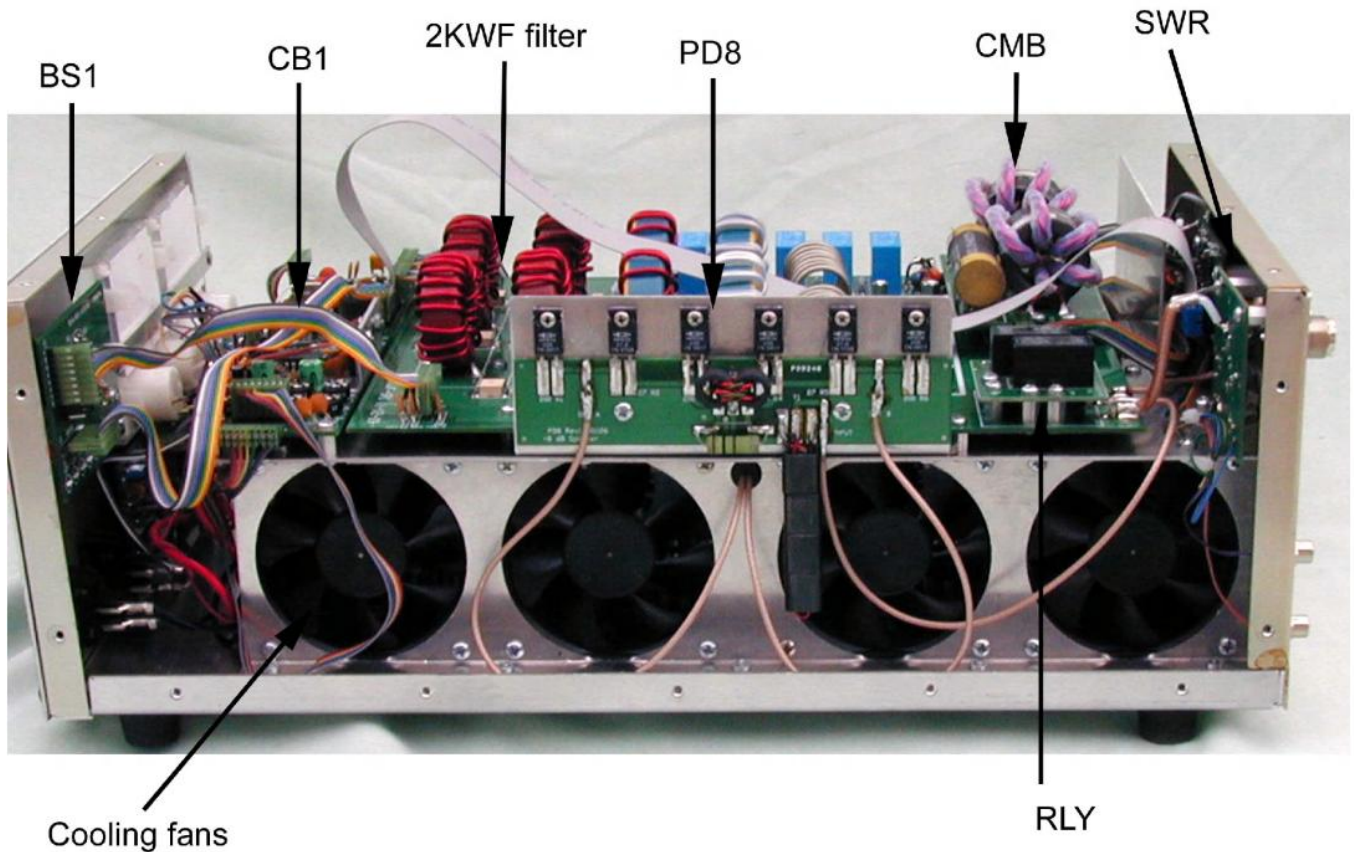
Source: FCC

Here is a view of the construction of the amp from the fan intake side.

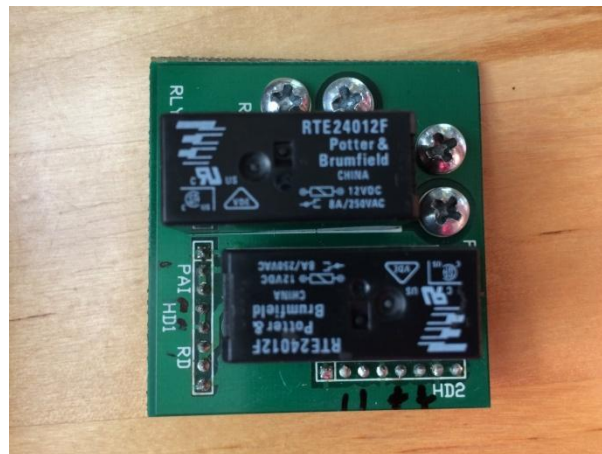
Source: Source: NG7M at <http://www.nc7j.com/>

I began with the removal of the **RLY** board. I kept each board and any screws removed in its own anti-static bag. The RLY board is attached with 4 screws and plugs into the filter board.

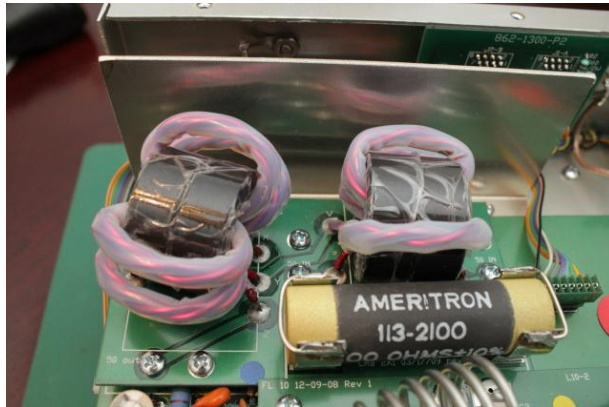
Source: worldwidedx.com

Next I removed the **CMB** board. Again it is screwed in place with no additional connectors.

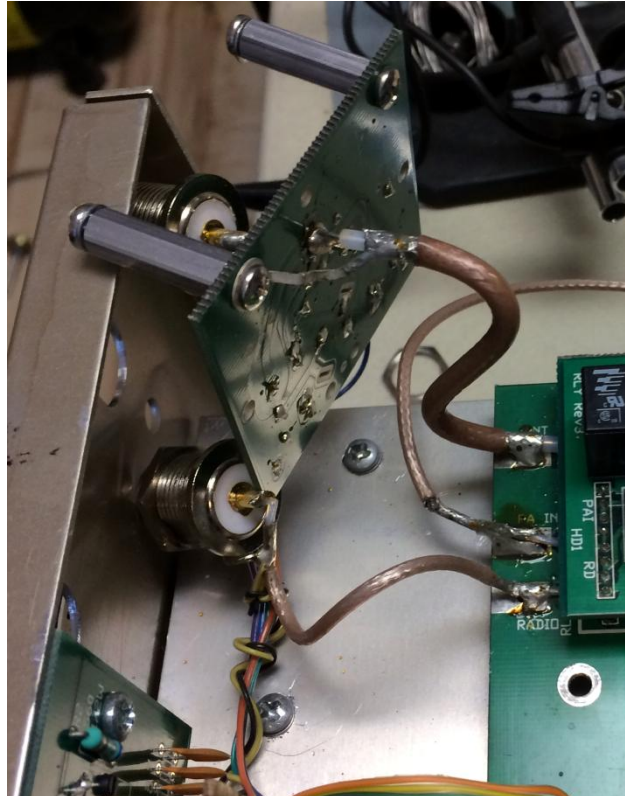
Source: NG7M at <http://www.nc7j.com/>

Continuing at the rear of the amplifier I removed the 2 nuts from the RF input and RF output SO-239 connectors. Remove the 2 screws holding the SWR board to the rear of the cabinet and carefully remove the RF Output Connector/SWR board through the rear chassis while it is still attached the filter board.

Loosen but do not remove the RJ45 board screws at the rear of the amp. This should give you enough room to remove the RF input connector while it too remains attached to the filter board.

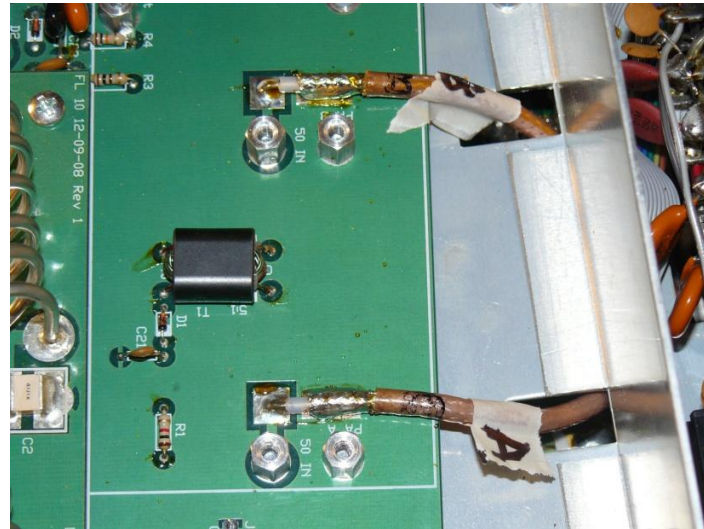
Source: VE7TK

Returning to the rear of the amp label and then unsolder the pair of RG-142 coaxes connecting the Power Amps (**PA-A** and **PA-B**) to the filter board. Use a little solder wick or a solder sucker to clean the hole in the filter board where the centre conductor was connected. This will make reassembly easier. (Note: This was the **ONLY** desoldering I found necessary.)

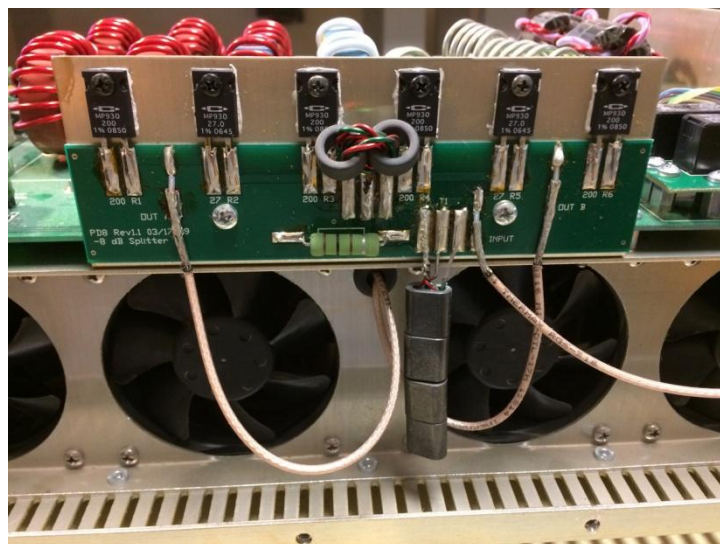
Source: NG7M at <http://www.nc7j.com/>

Remove **ALL** the screws holding the filter board in place. At this point (I think) the filter board can be removed. (Bag the screws and keep them with the filter board.) Next remove the screws attaching the power divider board (**PD8**) to the large aluminum shield. With the screws removed let the PD8 board fall to the side of the amp suspended by the 3 coax leads.

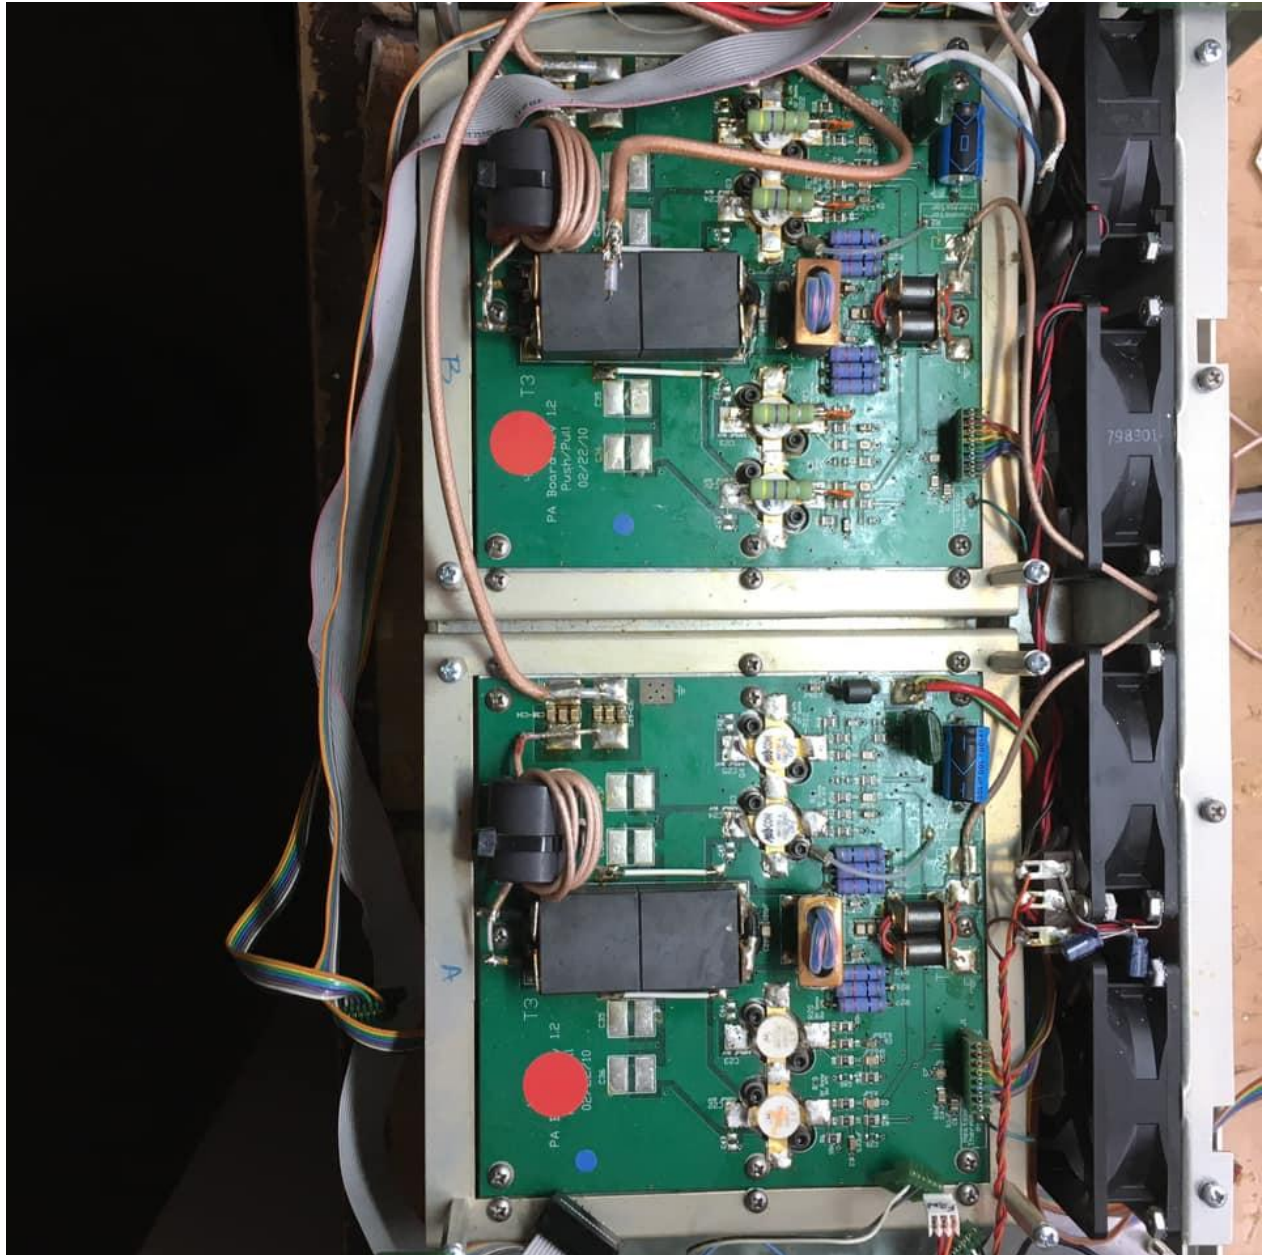
(Source: Ameritron Facebook Group, shows PA-A final transistors under repair -- Jason Harvey.)

Removal of the aluminium shield exposes the two identical 600 watt final amplifier boards. Each board is attached to its respective heatsink with 8 screws around the perimeter AND 8 screws, 2 per MRF150 TMOS-FET.

In addition, each board has pair of PT103-J2 thermistors. One is visible on the top side of the board and is connected to the tab of one of the innermost FETs. The 2nd thermistor is soldered to the PA board near **J1** and labelled at the lower right (near the fans) in the photo above is attached to the heatsink itself.

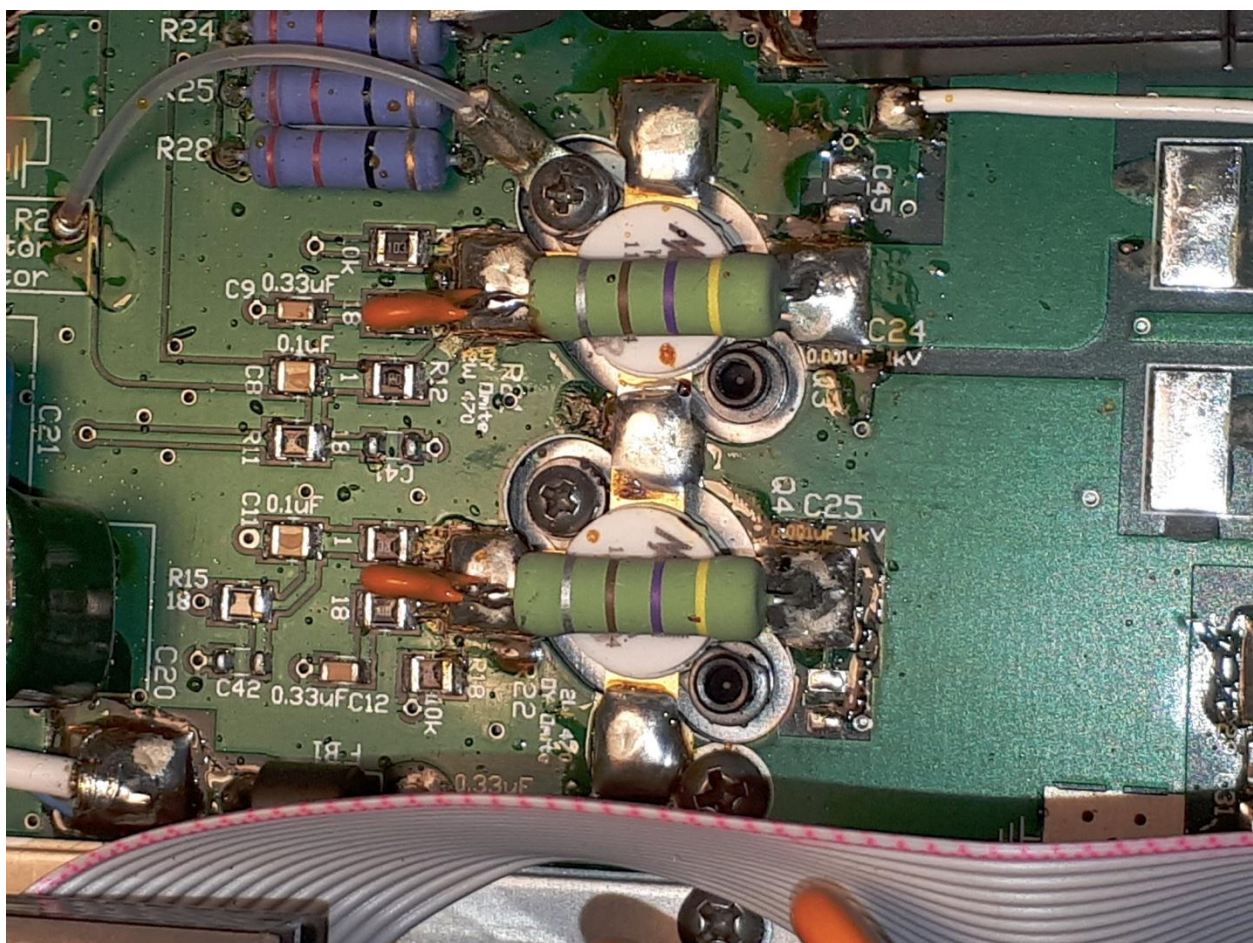
Source: VE7TK

Up until this point my visual inspection of all the PC boards had been very positive. The boards had been neatly soldered and clean. At this point however I was greeted with a pair of very dirty PA boards. Each board was covered in flux and flux splashes!

Before removing the boards from the heatsinks I gave them a thorough cleaning. The first pass was with a commercial flux remover and a tooth brush. This softened the coating. In some places it required a 2nd spray and brushing. Next I removed the remaining residue with 70% rubbing alcohol and cotton swabs from the XYLs makeup drawer. The final inspection removed any traces of cotton attached to components. (Luckily for me the underside of the boards was clean!)

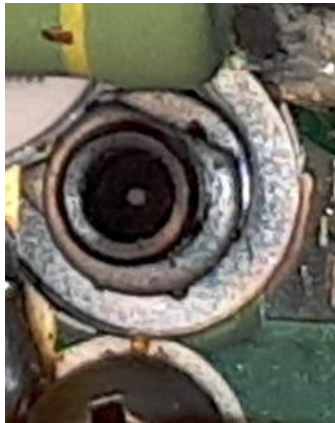
Source: VE7TK

CAREFULLY note that each screw has a **pair of Bellville washers** and a thicker washer with a flat side (as seen below). On my ALS-1300 each of the thermistors attached to a FET had a second thick washer above the lug containing the thermistor.

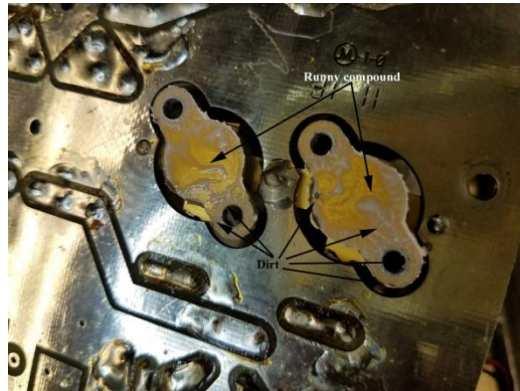
Source: Ameritron Facebook Group, W8JI

As was demonstrated in the video prepared by Tom, W8JI, I found the thermal compound on the transistors to be runny and unevenly applied. Below is a photo from Tom's video.

Following the instructions given in the video I lightly buffed the channel of the heatsink where the MFR-150 FETs mount with 2000 grit wet/dry paper. I followed that with final touch-up polishing with some rubbing compound and countersunk the FET screw holes. I cleaned up the surface of the heatsink with water followed by a good scub with rubbing alcohol. In addition I blew zero-residue cleaner into the transistor mounting holes to ensure they were clear of any foreign material. Here's the final result.
