3-Element SteppIR Rebuild

VE7TK – 2025

Rick Williams – August 2025

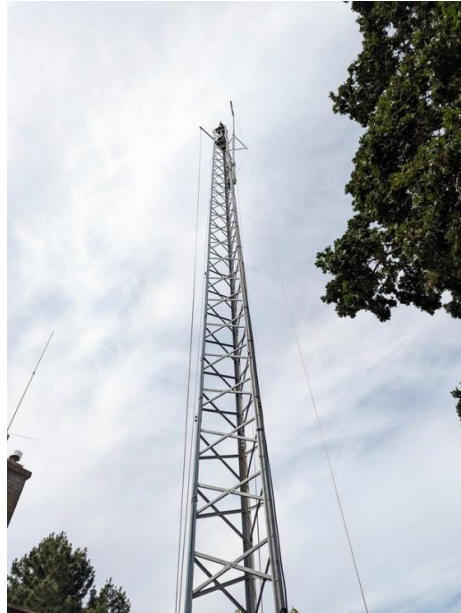
With the antenna on the ground it was becoming more and more obvious that maintenance was long overdue! One of the first things I noticed when the antenna was finally on the ground was how naked the tower looked!!
